# Manhole Inspection Summary

Manhole # S33KK\_031MH

Insp Date: **12/7/06 4:09 PM**

**Location** Address: **1818 MARYLAND AVE**

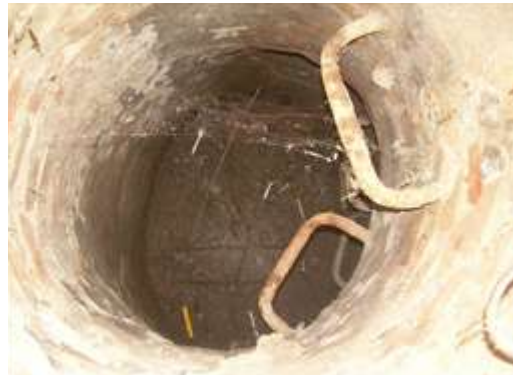
Top View

Corroded and missing steps. Channel debris.

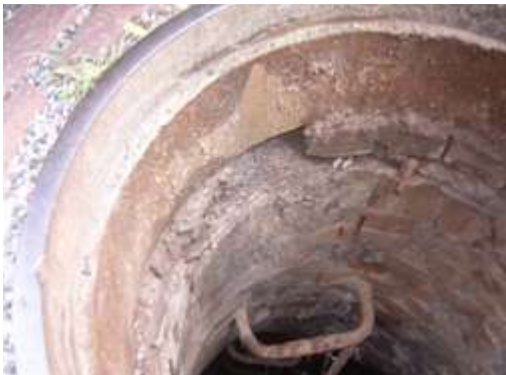
Defect

Frame leaks. Adjustment deterioration, loose brick and infiltration.

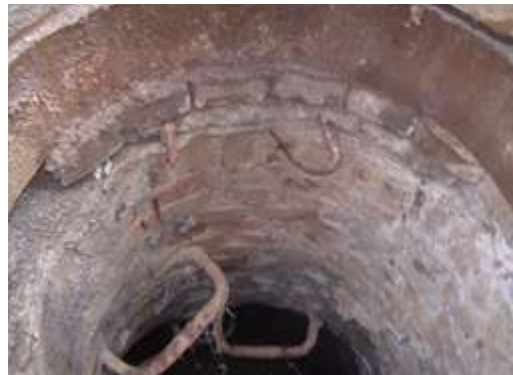
Defect

Frame leaks. Adjustment deterioration, loose brick and infiltration. Barrel infiltration. Corroded and missing steps.

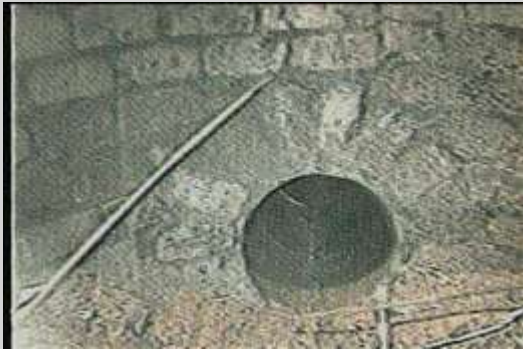
Pipe Out @ 12 O'Clock

Barrel deterioration and infiltration.
